# FLOOR TO CEILING REAL ESTATE INSPECTIONS LLC

## RESIDENTIAL INSPECTION

1234 Main St. Paragould AR 72450

03/09/2022 9:00AM

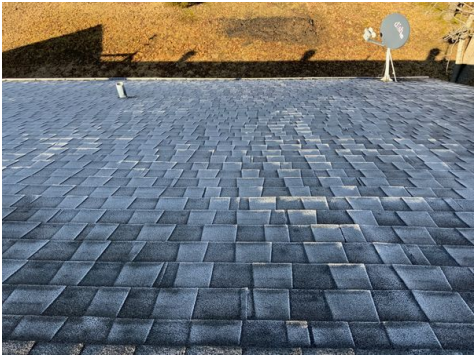
Flashing

**DIFFICULT TO SEE EVERY FLASHING**

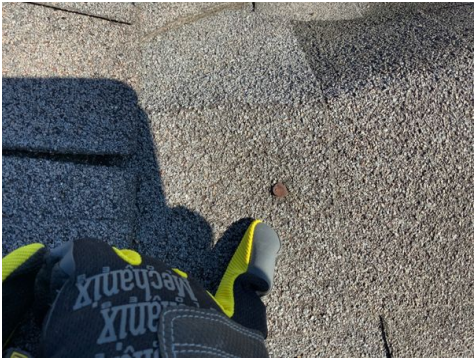
2.1.2 Roof Covering

**FASTENING DEFECT AT ROOF COVERING**

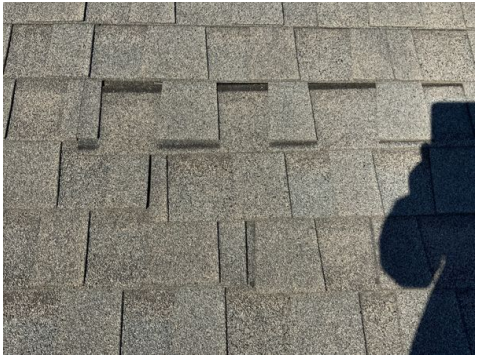
I observed improper fastening at the roof-covering materials. Prone to leaking. Correction and further evaluation is recommended.

Contact a qualified roofing professional.

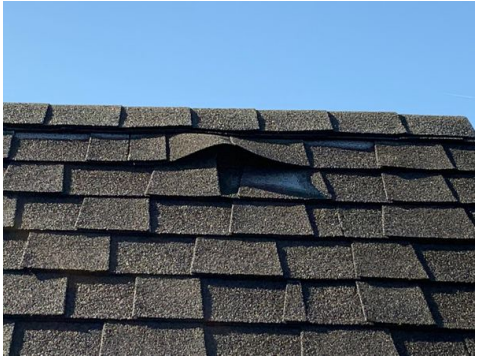
2.1.3 Roof Covering

INSTALLATION DEFECT AT ROOF COVERING

I observed indications of improperly installed roof-covering materials. This is not according to best practices or common standards. Defect. Prone to water intrusion and roof leaks. Further evaluation and correction by a roofer is recommended.

Contact a qualified roofing professional.

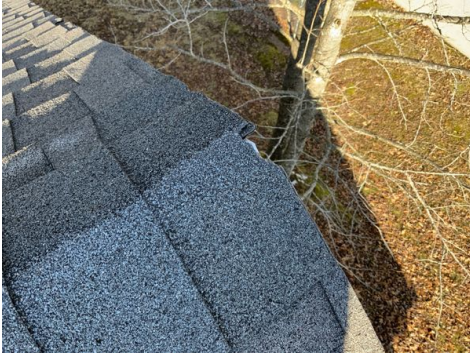
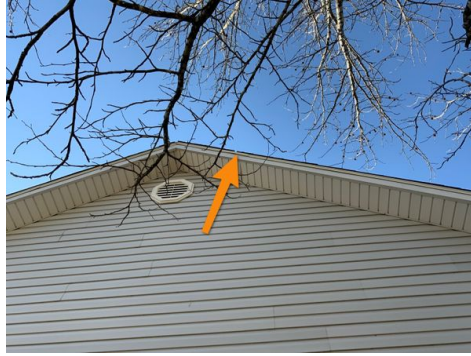
2.1.6 Roof Covering

DAMAGED SHINGLE(S)

I observed damaged shingles. Recommend repair by a licensed roofer.

Contact a qualified roofing professional.

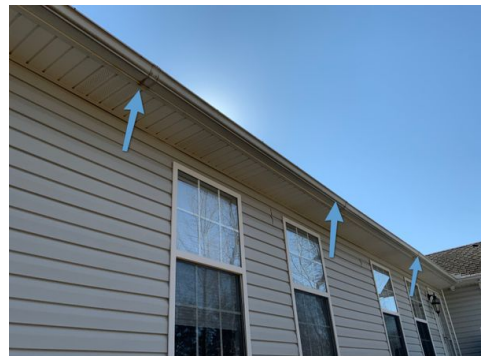
**GUTTER LEAKAGE**

I observed a water leak from a gutter, which could result in water not being properly collected and drained away. This is a defect that should be corrected by a professional contractor.

Contact a qualified gutter contractor

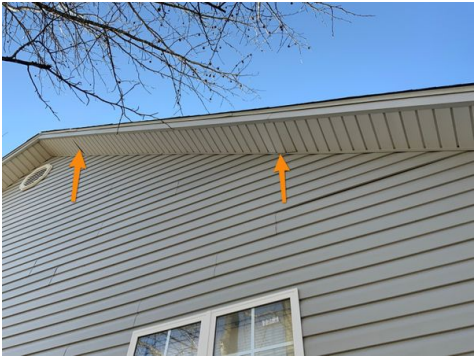
3.3.1 Wall-Covering, Flashing & Trim

**DAMAGED WALL-COVERING MATERIAL**

Recommendation  
Contact a qualified professional.

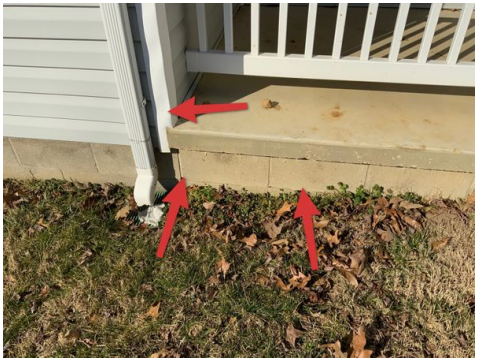
3.3.2 Wall-Covering, Flashing & Trim

Monitoring the masonry walls of the house is needed. Although masonry can deform elastically over long periods of time to accommodate small amounts of movement, large movements normally cause cracking. Cracking can result from a variety of problems: differential settlement of the foundation; drying shrinkage; expansion and contraction due to ambient thermal and moisture variations; improper support over openings; the effects of freeze-thaw cycles; the corrosion of iron and steel wall reinforcement; differential movement between building materials; expansion of salts; and the bulging or leaning of walls.

Further evaluation is recommended by a licensed structural professional.

Recommendation  
Contact a qualified structural engineer.

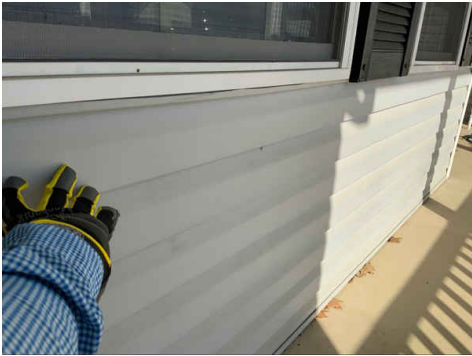
3.3.3 Wall-Covering, Flashing & Trim

I observed indications of loose areas of the exterior wall-covering material. Correction and further evaluation is recommended.

Recommendation  
Contact a qualified professional.

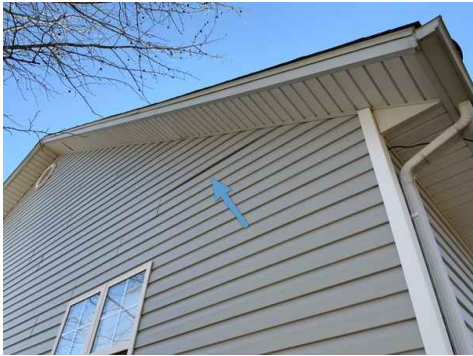
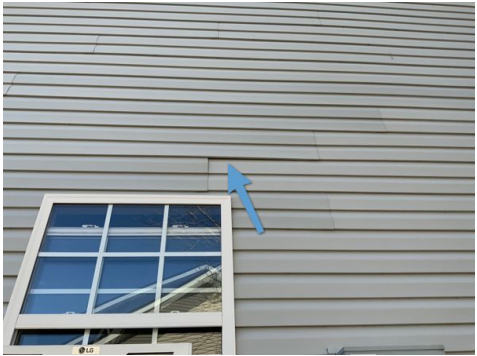
3.4.1 Vegetation, Surface Drainage, Retaining Walls & Grading

Front Porch under window

**EROSION CAUSING DAMAGE**

Recommendation

Contact a qualified professional.

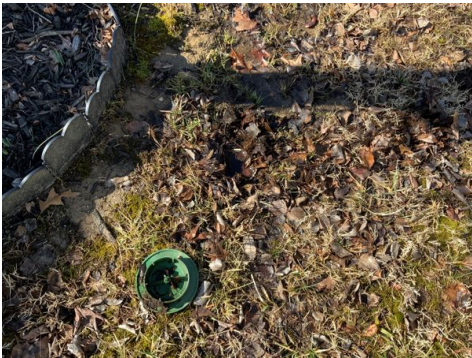
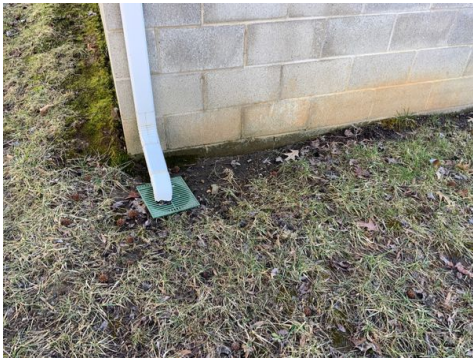
3.6.1 Walkways & Driveways

**IMPROPERLY SLOPED DRIVEWAY SURFACE**

Recommendation

Contact a qualified driveway contractor.

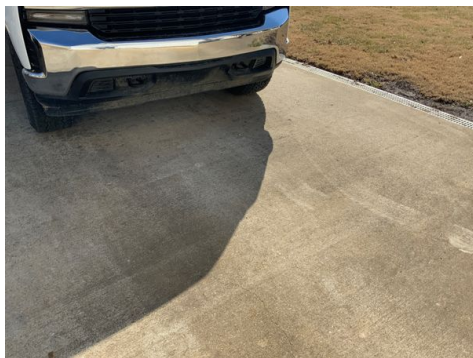
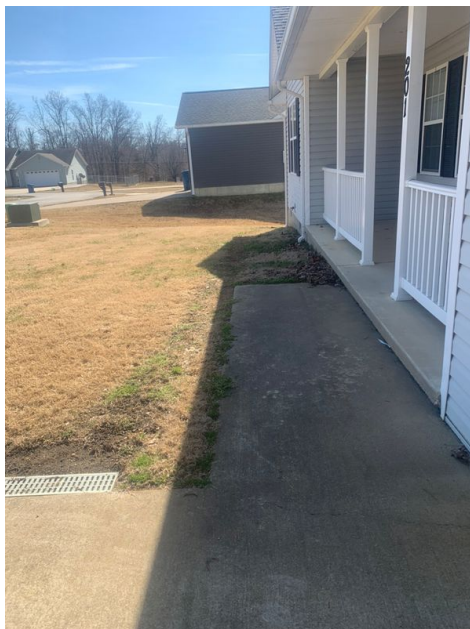
### 3.8.1 Porches, Patios, Decks, Balconies & Carports

#### **DECK COMPONENTS DIRECT GROUND CONTACT**

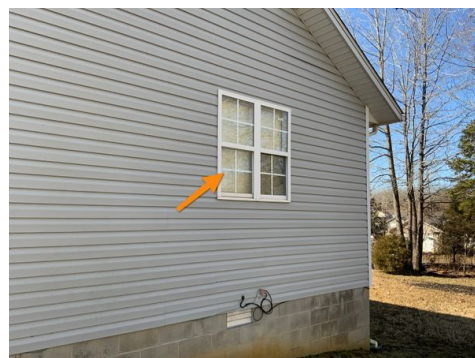
### 3.12.1 Exhaust Hoods

#### **CLOGGED DRYER EXHAUST HOOD**

Recommendation

Contact a qualified appliance repair professional.

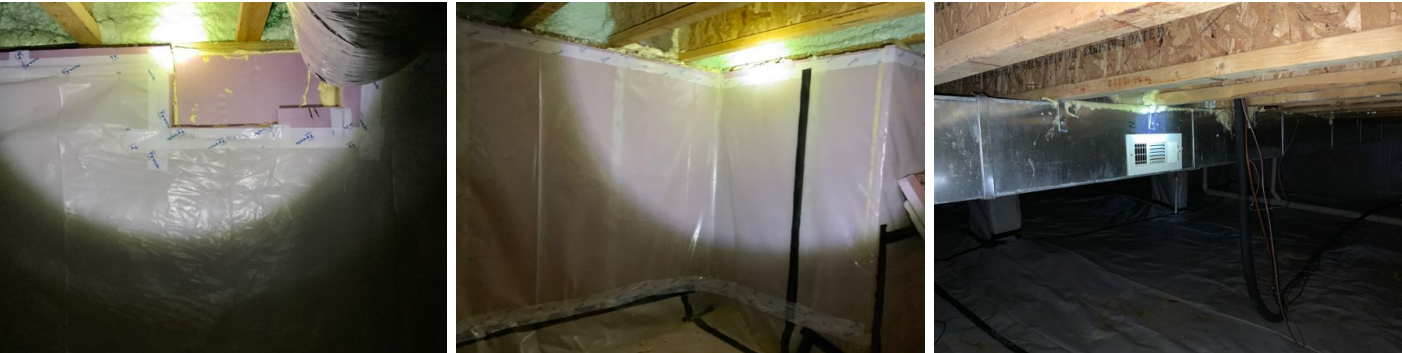
Crawlspace was conditioned

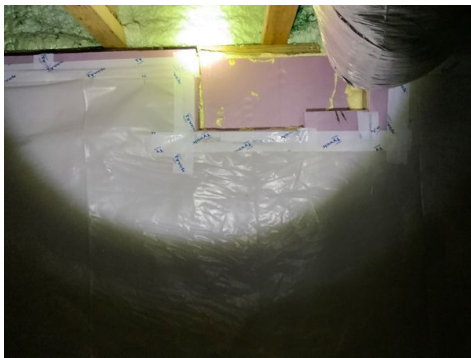
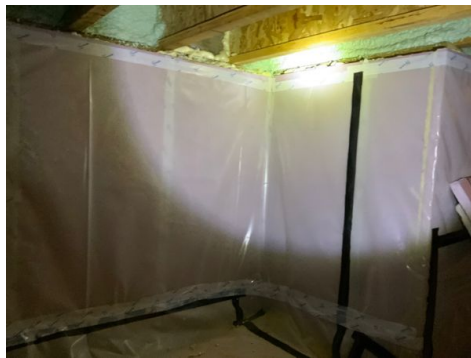
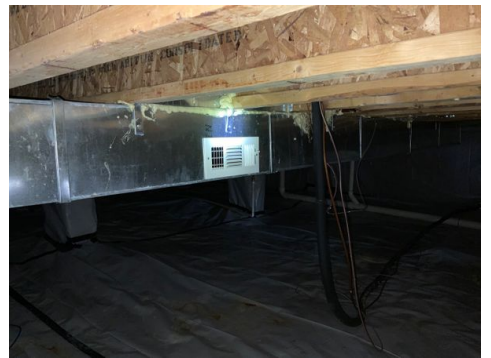
### Ventilation in Crawlspace

#### ENCAPSULATION RESTRICTION

Crawlspace was encapsulated making visual inspection restricted. Encapsulation prevents the visual inspection of most Crawlspace components including but not limited too; foundation walls, columns, Crawlspace floor, rim joist and sill plates. Recommend the encapsulation work be evaluated by a qualified professional and monitor structural components of the home.

#### ENCAPSULATED CRAWLSPACE

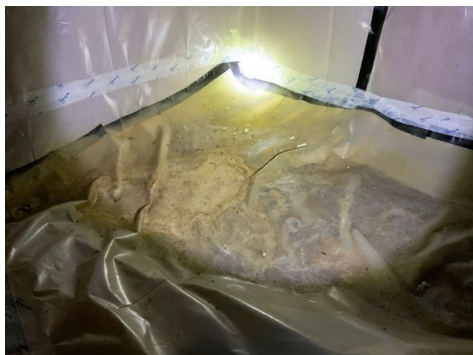
Crawlspace floor was soft indicating moisture intrusion.

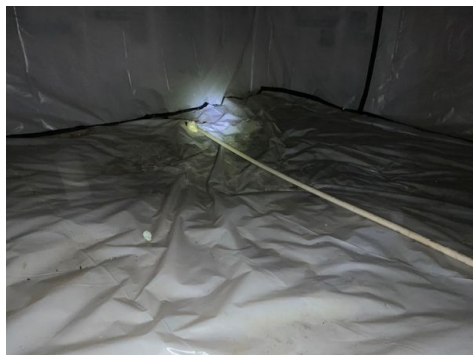
#### 4.2.2 Under-Floor Crawlspace

### FOUNDATION CRACK - MAJOR

Recommendation

Contact a qualified structural engineer.

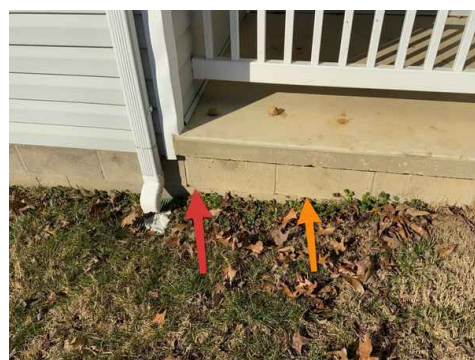
#### 4.4.1 Ventilation in Crawlspace

### CRAWLSPACE ENCAPSULATED

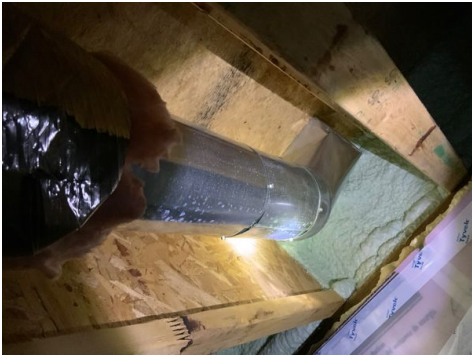
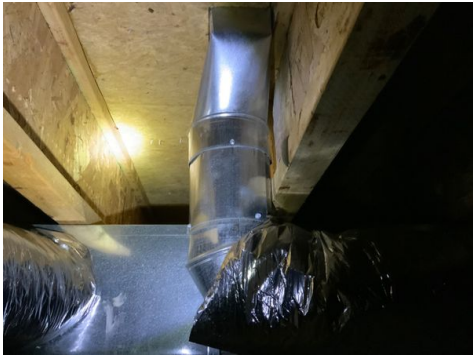
6.1.1 Heating System Information

I observed areas of missing insulation on distribution duct. Recommend additional insulation.

Recommendation  
Contact a handyman or DIY project

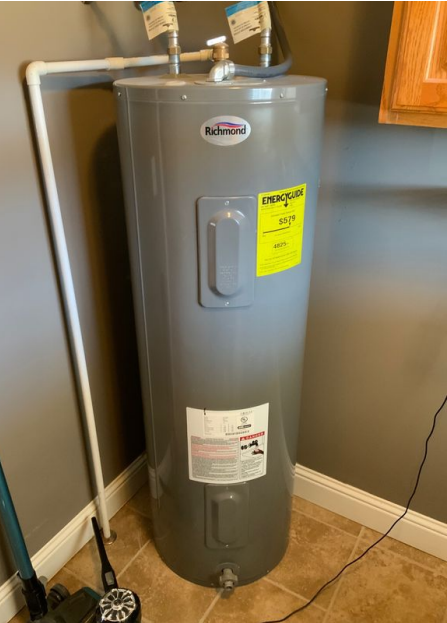
Hot Water Source: Inspected Seismic Bracing

I inspected the seismic bracing for the hot water tank. Recommend additional bracing.

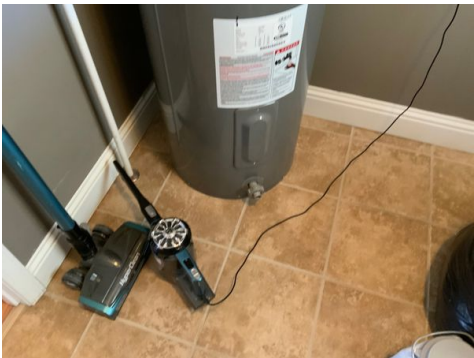
7.3.2 Hot Water Source

OLD SYSTEM

Recommendation

Recommend monitoring.

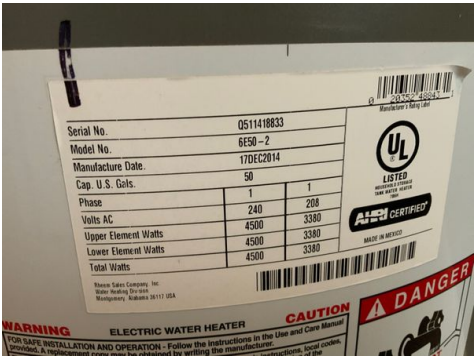
7.4.1 Drain, Waste, & Vent Systems

SEPTIC SYSTEM

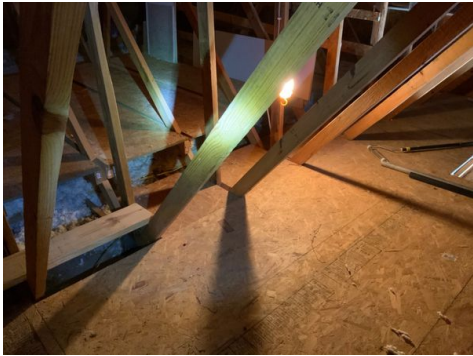
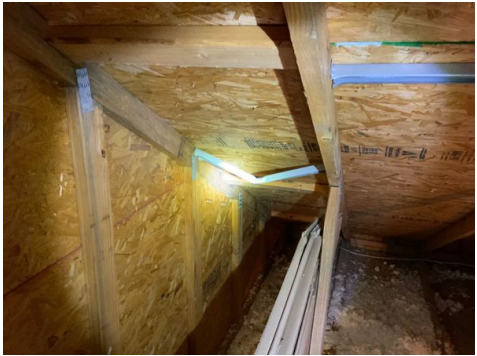
Trusses had been modified for storage. Recommend evaluation by a qualified professional.

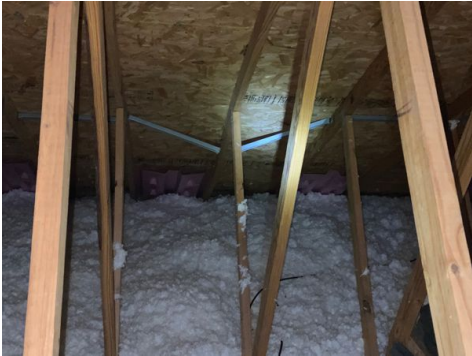
Bent truss stabilizers

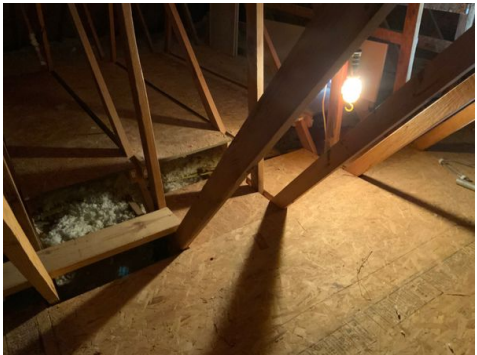
9.1.3 Structural Components & Observations in Attic

**MISSING LIGHTING FOR ATTIC STORAGE**

Recommendation

Contact a qualified electrical contractor.

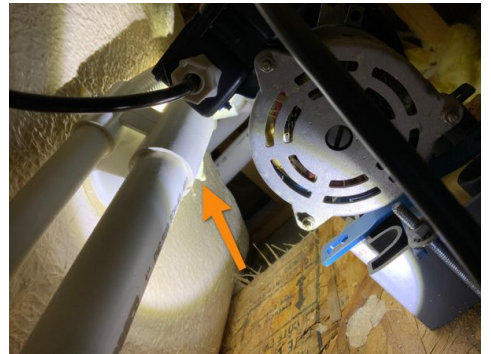
## 11.3.2 Hydromassage Bathtub

**TUB STOPPER DEFECT**

Recommendation

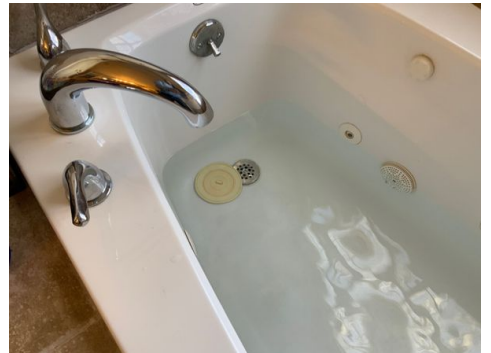
## 11.3.3 Hydromassage Bathtub

**NON-FUNCTIONAL JETS**

I observed one or more jets that did not function properly.  
Recommend repair by a licensed plumber

Recommendation  
Contact a qualified plumbing contractor.

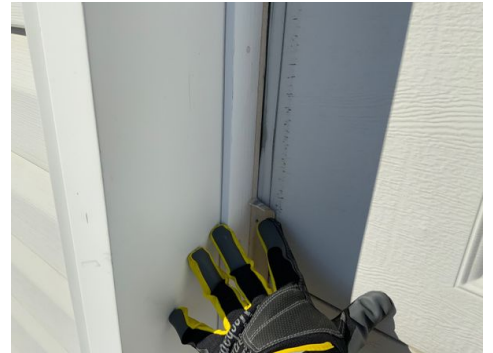
### 13.3.1 Garage Vehicle Door Opener

#### **PHOTO ELECTRIC EYE WAS DAMAGED**

Photo electric eye was damaged but functional. Recommend repair

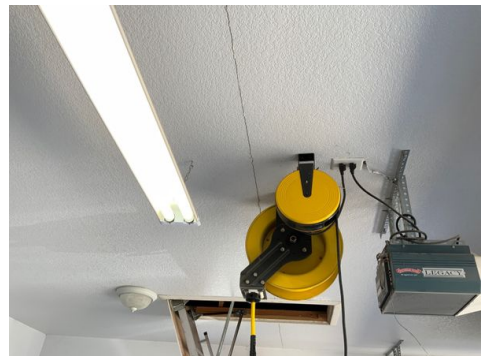
Drywall damage appeared to be due to overloading modified trusses in the attic. Recommend further evaluation by a qualified professional.

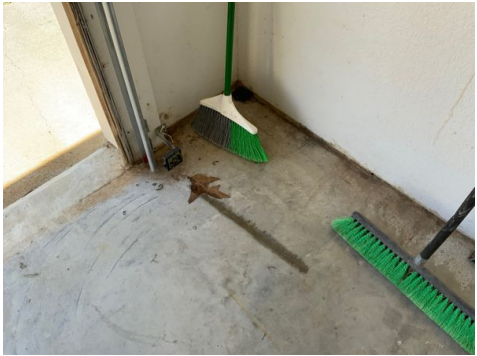
## 13.6.1 Moisture Intrusion in Garage

I observed indications of active moisture intrusion (water penetration) into the garage.

Recommendation  
Contact a qualified waterproofing contractor

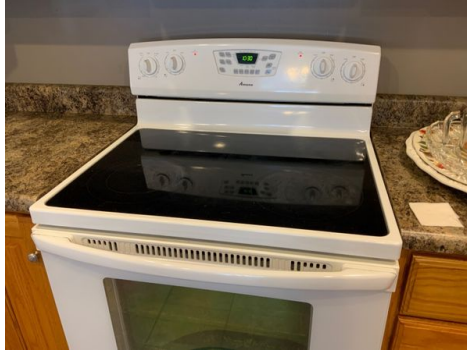
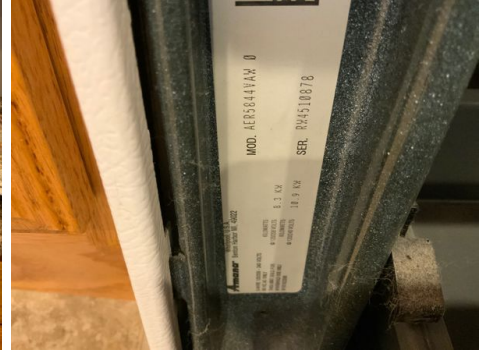
Range light was on prior to inspection. Recommend repair.

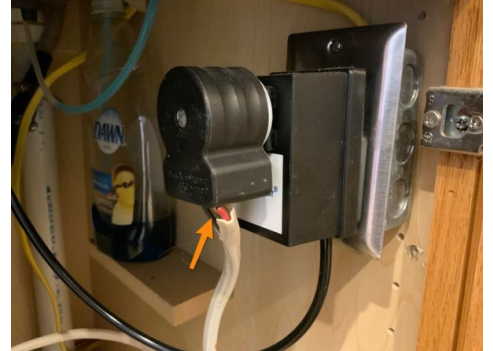
### 15.3.1 GFCI

#### **MISSING GFCI PROTECTION**
